(OS-1 manual addendum)

These are unofficial corrections for the 12th edition of the Rockwell Collins 305-1 manual. This data was compiled during a recent rebuild and refurbishment of a 305-1, part-by-part. Corrections listed here are not endorsed, nor confirmed, by Rockwell Collins. Listed below is what I found to be in error.

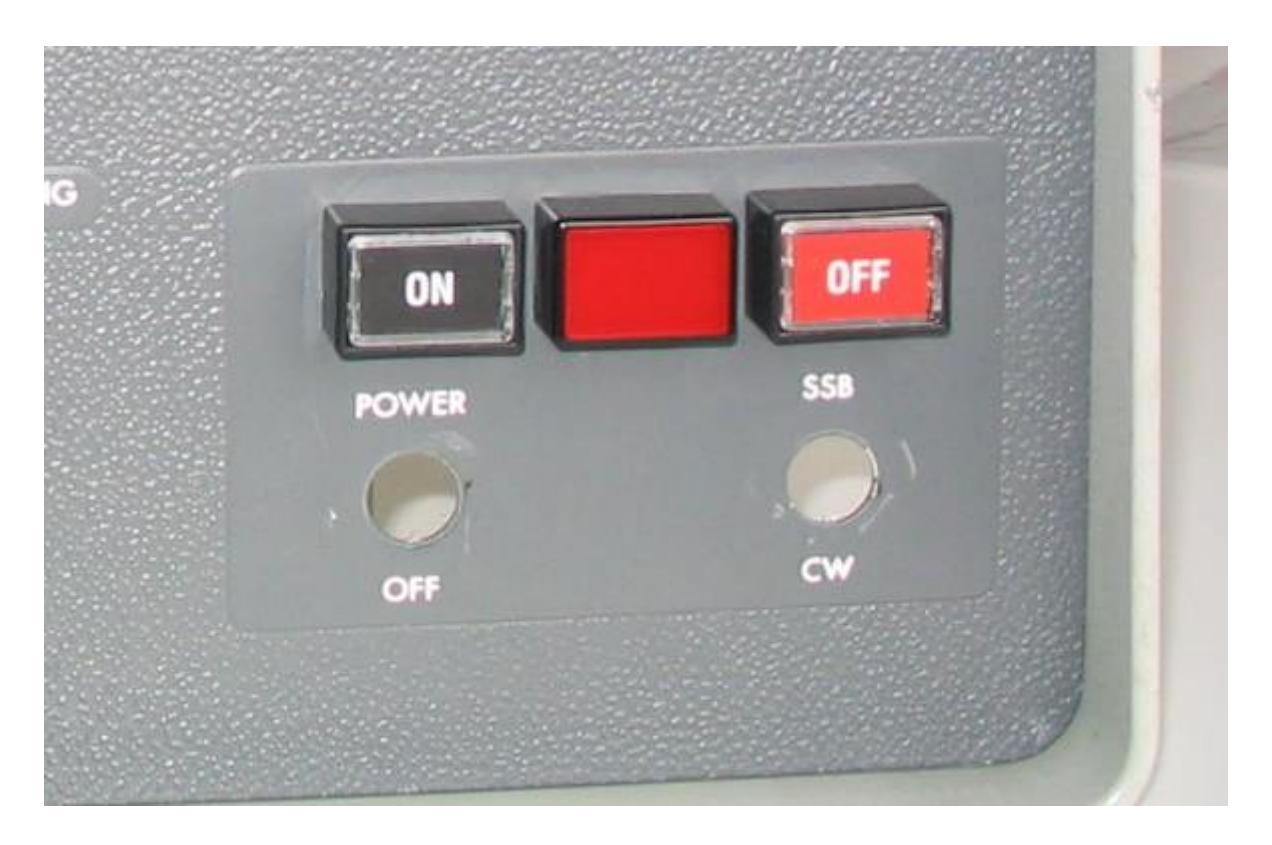
Figure 1, As ordered from Rafi

Figure 1, below, shows these parts as they were ordered through my ITT-CK Cannon distributor. Basically, only the push-button and plunger are different now to allow for various removable lens-caps and legend plates. The custom plunger mechanism used in the originals, a solid block of plastic fuse to the plunger, is long gone. While the housings are still identical, save the old metal locking rings (and the lamp socket from the indicator). The plastic rings supplied will suffice, but don't toss your (aluminum) treaded rings if they're still in hand. A spanner tool is available if you feel it's necessary to lock-down the new plastic rings (p/n 5.58002.019).

As ordered from Rafi

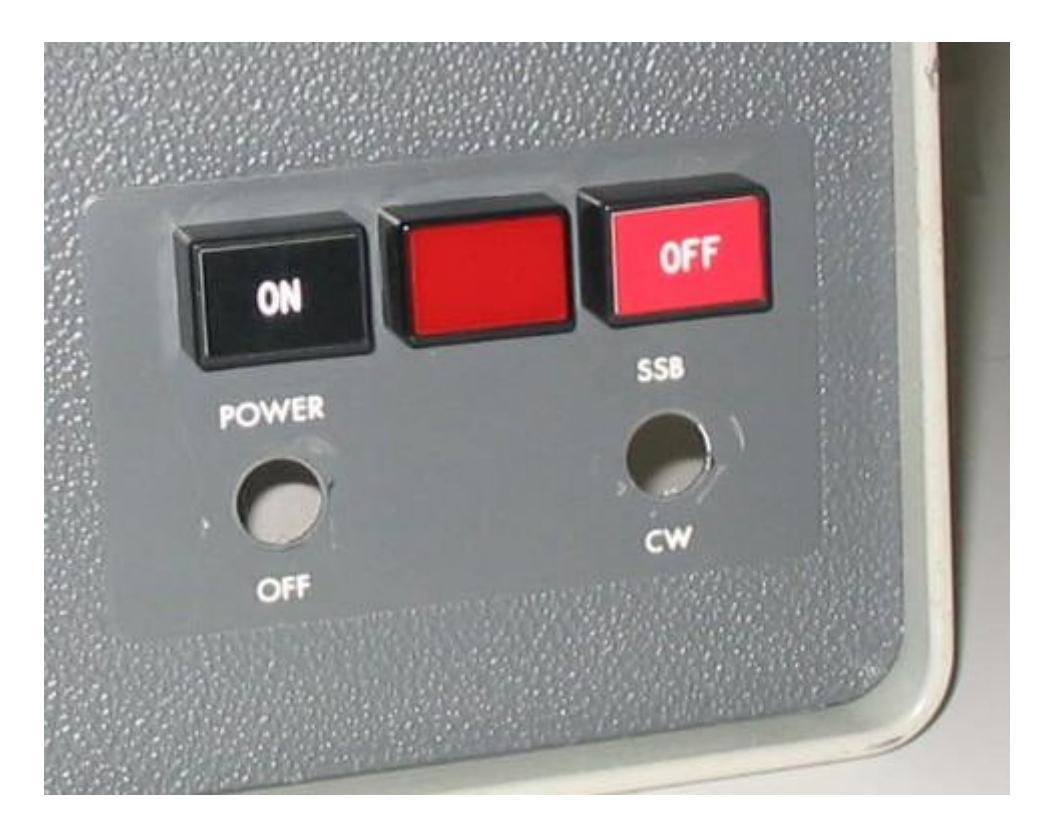
Figure 2, With engraved lens caps

I was not disappointed with the lens caps provided, but I felt a more original "look" was necessary. I then searched out the chap who engraves our club's call-letter badges. For a dollars each he cut a few "OFF" and "ON" plates using the same shade of red and black plastic. It took two tries to match the size and fit, but he succeeded. One dab of plastic cement and it was done. Figure 2 illustrates the end result. A long lasting, Collins-looking, engraved cap.

Fig 2. With engraved lens caps
