**Title:** Restoring a Heathkit

**Author:** Ralph C. Craig, AJ8R

# Restoring a Heathkit

Bringing a classic radio back to life can be a challenge, but as the author found, it's likely to be a rewarding one.

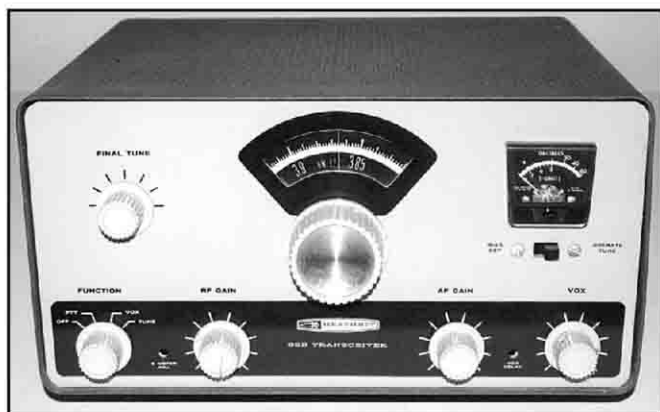
Figure 1—Heathkit HW-12 SSB transceiver, introduced and first sold in 1963.

I had become quite curious, so...after a week had passed, I opened the box. Removing some newspapers that were used as padding, I noticed the date on a page, a day in April of 1967... 35 years prior. This transceiver was older than half of the local radio club's members! As I removed it, a few items, including the instruction book, fell out of the box. There, sitting before me, was a Heathkit Model HW-12, 80 meter Single Band SSB Transceiver, in good condition and far from the "junk box" candidate I had expected to see (see Figure 1).

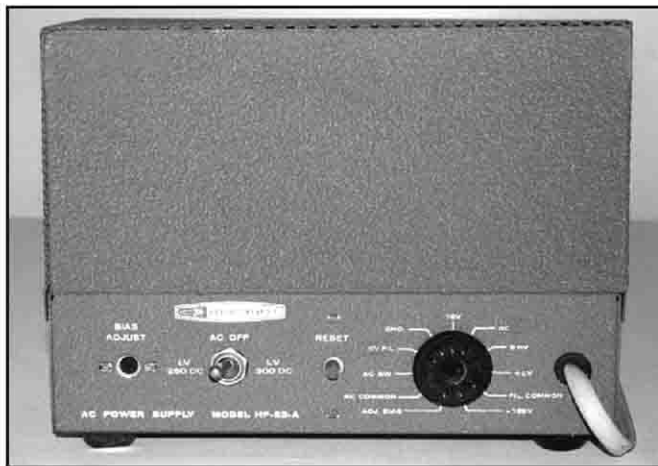
**Figure 5—The Heathkit HP-23A power supply. Note the 11-pin socket that needed a plug and the 2 conductor ac cable that was replaced with a 3 conductor grounded type.**

With the power supply operating properly, it was time to energize the transceiver. There was, however, one last item. Where was the power cable that connected the power supply to the transceiver? In my excitement while restoring the units, I had overlooked this cable. A search revealed that no cable came with the units, nor could my benefactor find one. I would have to fabricate one. The transceiver end of the cable used a standard 8-pin octal tube socket. The power supply end was different; it used an 11-pin plug and socket (see Figure 5).

original physical condition? I decided to compromise. The original capacitors were hollowed out, leaving only the outer shells. I then inserted replacement units into the shells and reinstalled the new package. The original physical appearance was thus retained, but with new, modern components. A second appearance item took more thought. The power supply ac line cord was the old non-grounding, non-polarized type, having only two conductors. Should I replace the cord with a grounded line cord with the ground conductor connected to the metal case? Safety won out and I installed a 3-wire grounding cord.

One end was cut off. Unplugging the cable to dispose of it, I quickly glanced at the end...hooray! Here was the exact plug I had so desperately searched for. I removed the plug and assembled the power cord, being cautious to use wire with the proper voltage rating, as at least one of the conductors had to handle 800 V dc safely.
