# **ATLAS 210X LIMITED EDITION REPAIR AND RESTORATION A VERY INTERESING PROJECT !**

**By SV9DRU**

## **Installing the Cumbria designs X-lock stabilizer to the 210x. A Greek twist to the PA0FRI project.**

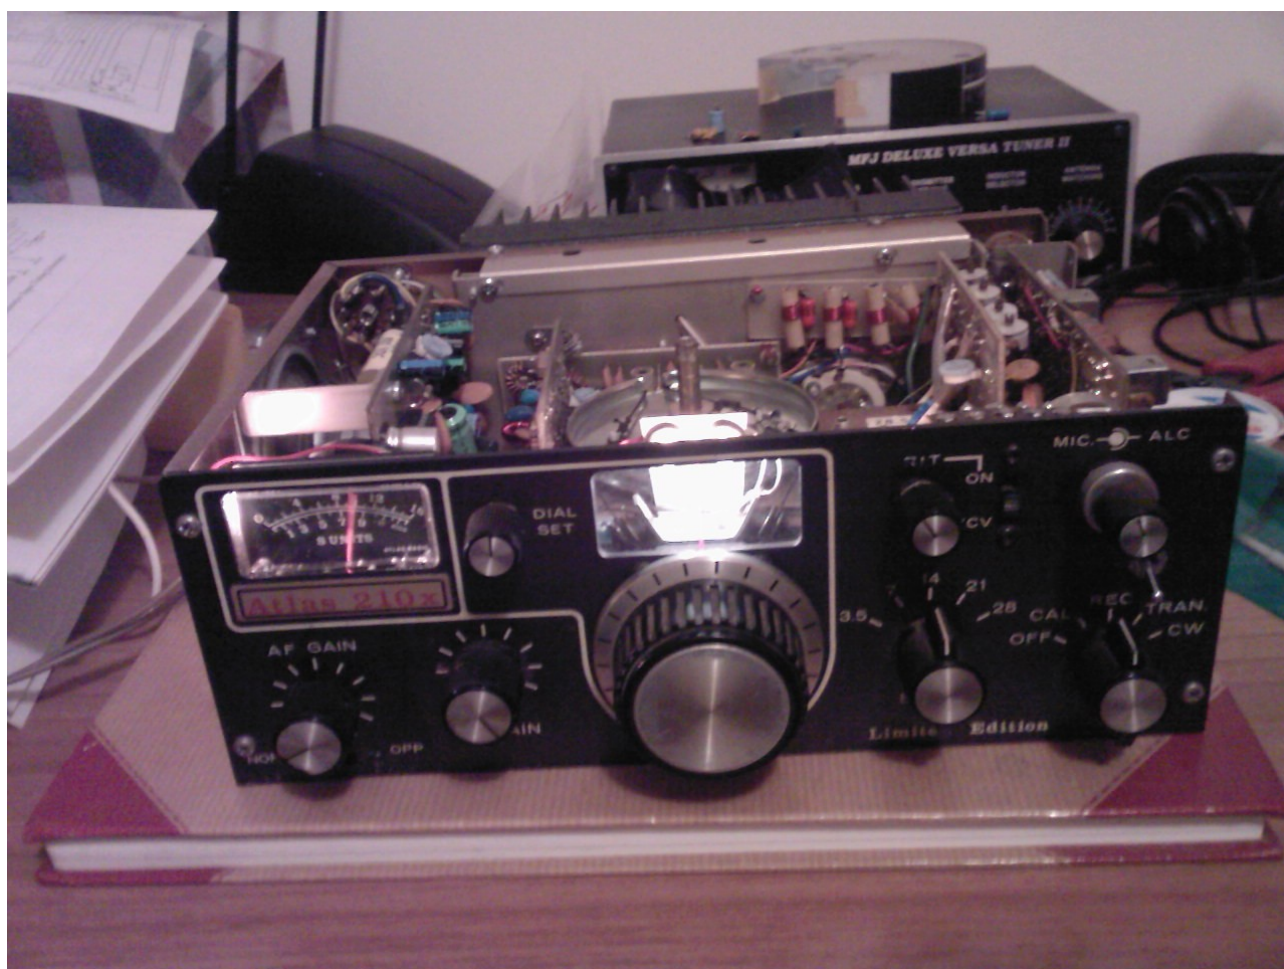
**My 210x in the middle of the project: There seem to be good glimpse of hope for this radio to be restored, I was thinking at the time !**

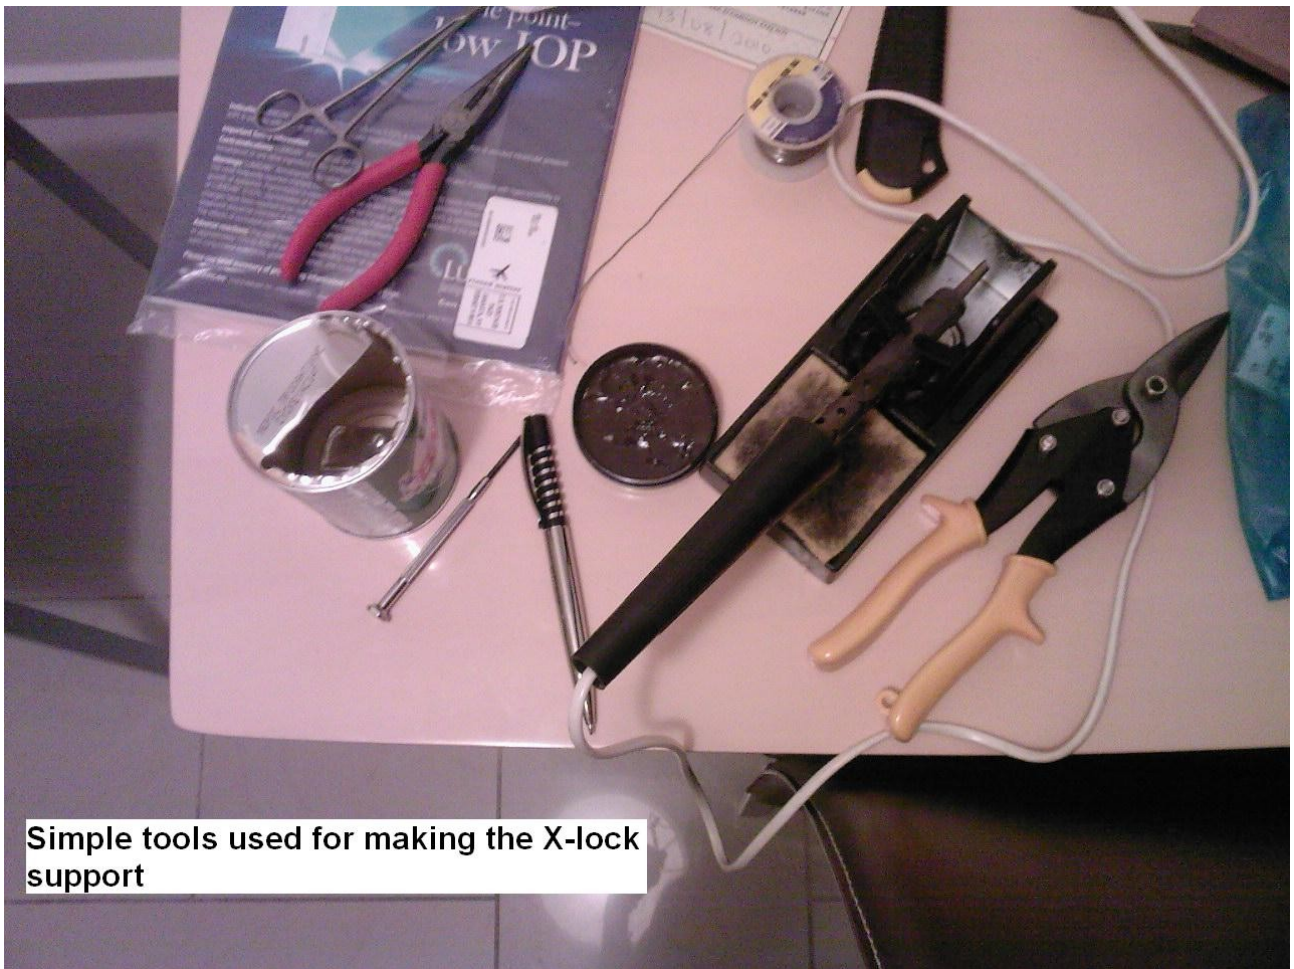
Simple tools used for making the X-lock support

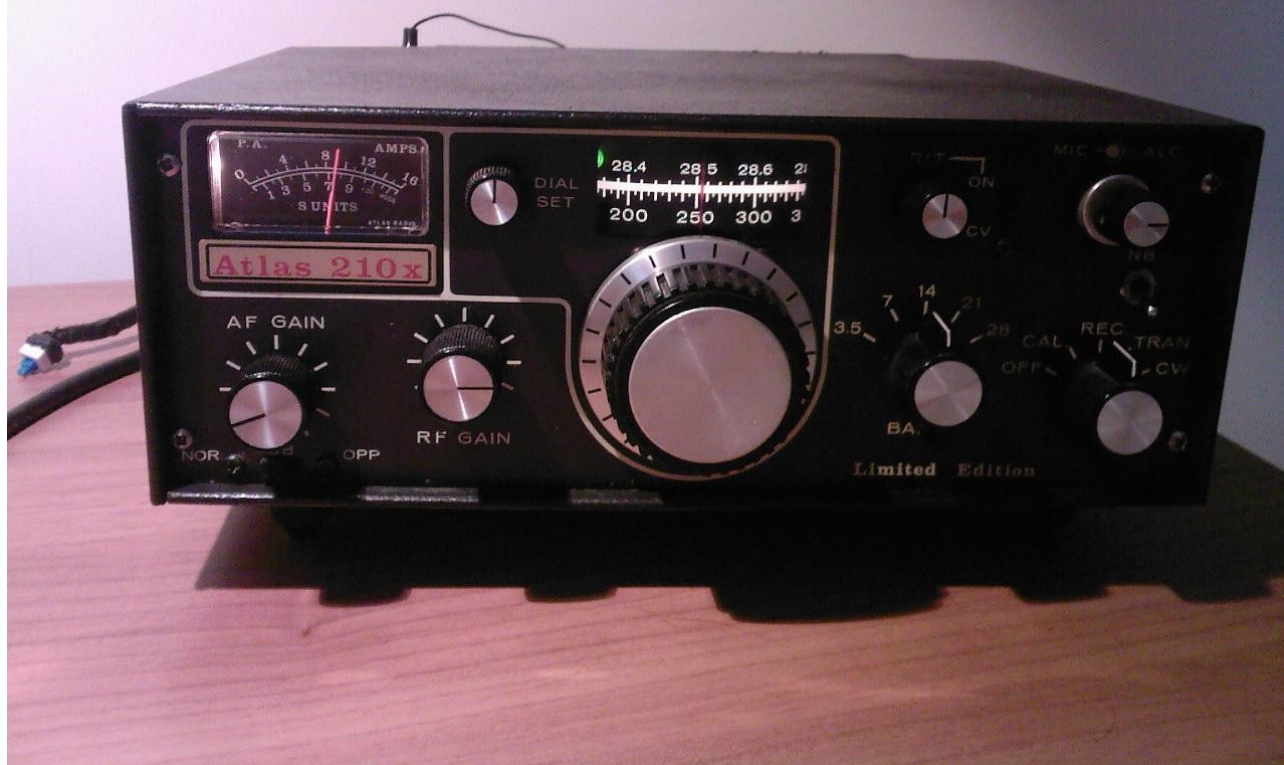
**Atlas 210x Limited Edition after repair and restoration. Excellent Rx-Tx in a small package**
